DEPARTMENT OF NATURAL RESOURCES  
DIVISION OF OIL, GAS AND MINING

RE: Site Inspection, Natural Organic Fertilizer Mill Site, S/019/054, Grand County, Utah

Date of Inspection: May 29, 2003  
Time of Inspection: about 8:00 to 9:15 p.m.  
Conditions: Mostly cloudy with thunderstorms in the area, 80's  
Participants: Paul Baker (DOGM)

**S/019/054, Natural Organic Fertilizer Mill**

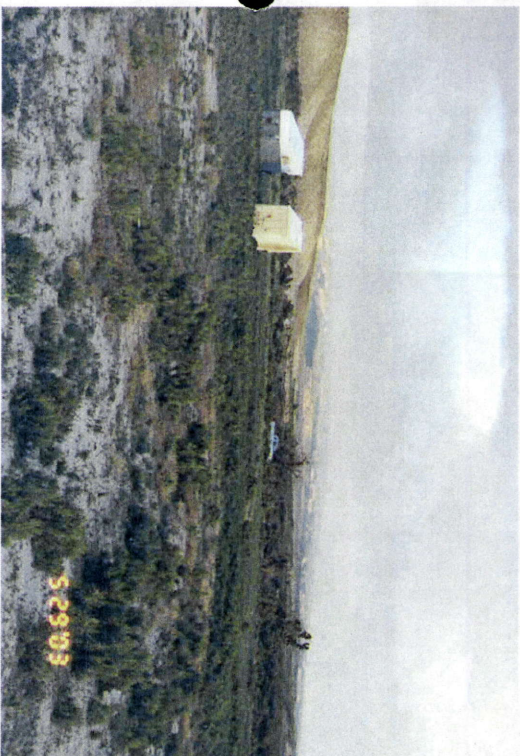
The mill site is next to Westwater Creek north of I-70 not far from the Colorado border. Most of the disturbed area is above the creek flood plain, but there is some screening equipment among the tamarisks in the flood plain. The portion of the site above the flood plain has been cleared of brush and some soil, probably with a dozer. In this area are two frac tanks (Photos 1 and 3) and a pit about 100 feet long, 30 feet wide, and 10 feet deep (Photo 2).

There is a large patch of Russian knapweed, a noxious weed, near the frac tanks. Most of the vegetation in Photos 1 and 3 is Russian knapweed. Closer to the edges of the bladed area, a lot of greasewood has become established.

**Photo 1. Frac tanks and some of the disturbance.**

The operator should attempt to control the Russian knapweed. This is a rhizomatous perennial plant that will require persistence to control.

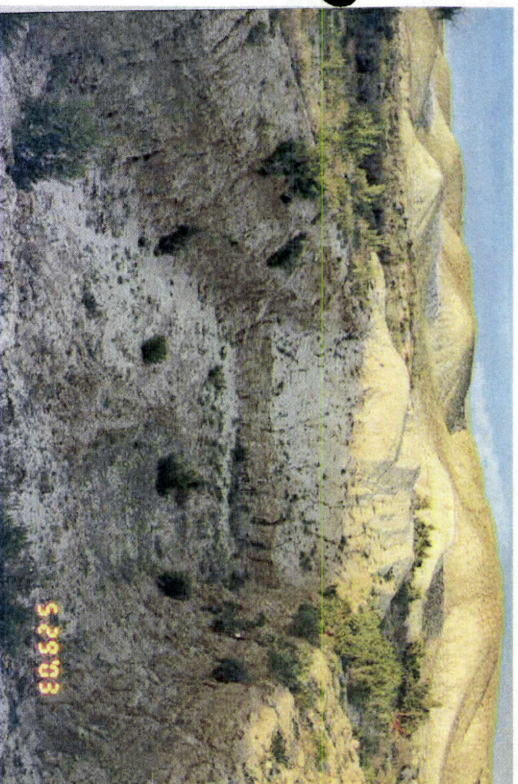
**Photo 2. Pit near the north side of the disturbed area.**

Although the amount of area disturbed places the mine in the category of a large mine, little or no reclamation would be required for the Division to release much of the disturbance. The site is not in compliance but could be brought back into compliance by staking out a five-acre area that includes the equipment, the trench, and non-native vegetation.
